RE: POTENTIAL ISSUE ON MICO "530" STYLE BRAKES

530 Series Spring Brakes

SERVICE BULLETIN

INFORMATION BULLETIN NO. 88

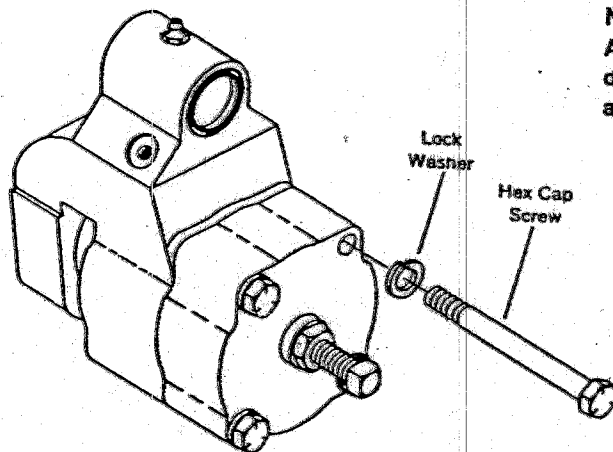
Note Date Code location.
Affected brakes will have a
date code between 00 C 000
and 02 C 015.

This service bulletin is intended to provide instructions for replacing the four housing assembly hex cap screws with new hex cap screws provided in conversion kit 02-500-232.

Housing cover is under spring tension. It is very important that only one hex cap screw is removed and replaced at any given time.

1. Remove one of the existing hex cap screws and lock washers. Install new lock washer and new hex cap screw from conversion kit. Torque new hex cap screw 29.8-36.6 N-m (22-27 lb-ft).
2. Replace the remaining hex cap screws and lock washers, one at a time, and torque 29.8-36.6 N-m (22-27 lb-ft).
